17TH ROAD SAFETY CONFERENCE

TESTING TRAFFIC CALMING EQUIPMENT TO IMPROVE SAFETY IN HIGHWAY WORK ZONES

Marco Pereira Infrastructure Intelligence Technician (Road Safety Unit) mapereira@ascendi.pt

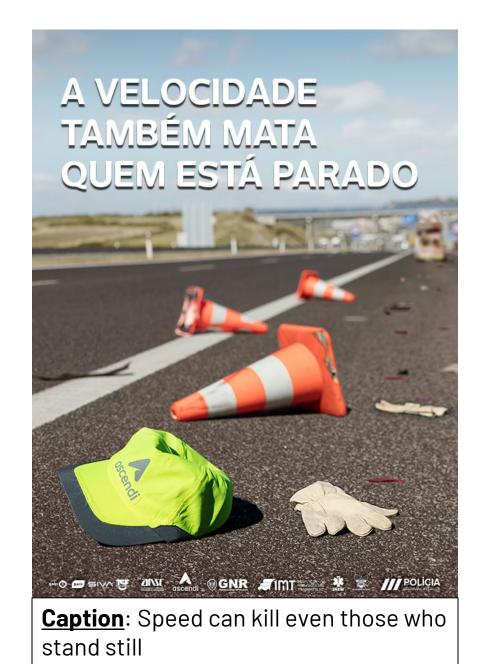
The problem: Speeding in Workzones

- Speed monintoring in 3 road closure locations during road pavement works
- Results displayed high values of Non-Compliance with the speed limit (%)

Costa de Prata	Norte Concession	
Measuring Point	(A29)	(A11)	
	04/11/2022	Location 1 11/11/2022	Location 2 11/11/2022
Speed Limit	80 km/h	80 km/h	80 km/h
Average speed (Vd)	76 km/h	69 km/h	69 km/h
Maximum Speed (Vmax)	154 km/h	110 km/h	106 km/h
V85 (85th percentile)	87 km/h	85 km/h	86 km/h
Non-Compliance (%)	31 %	23%	23%

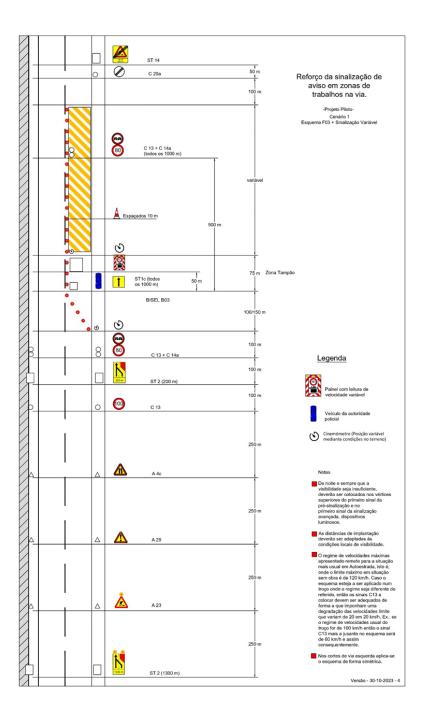
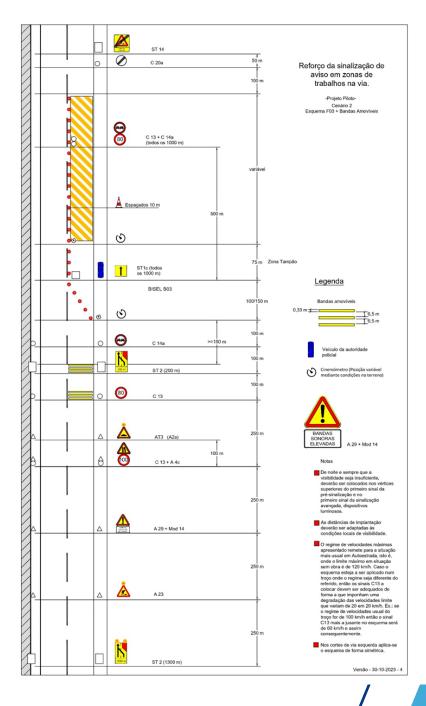
Location: Highway A25, Kilometre 100

Road Work: Reinforcement of an excavation slope

Road Constraints: Right Lane Closure

Equipment Used: DSS + TRS

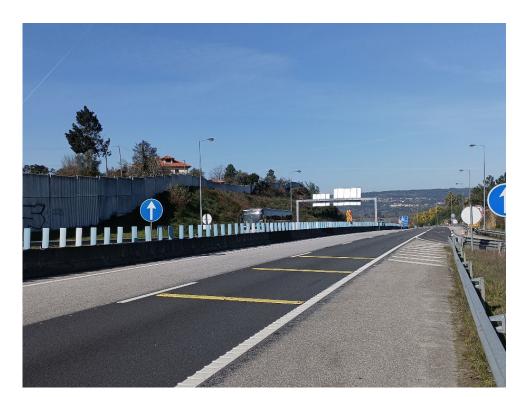
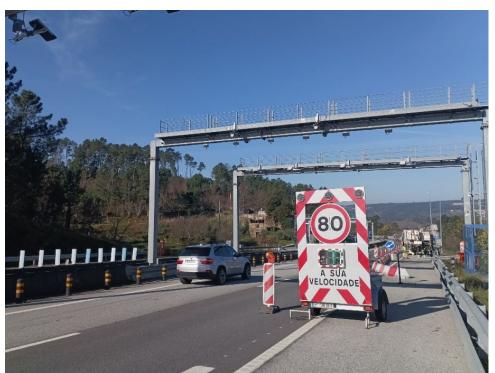
- Scenario 1 No additional equipment used
- Scenario 2 DSS
- Scenario 3 TRS

- With the installation of the DSS (Scenario 2) and the TRS (Scenario 3):
 - ➤ The percentage of non-compliances fell significantly;
 - ▶ Both the V85 speed and average speed, presented satisfactory reductions on both scenarios;
 - ➤ A gradual small displacement of the TRS was verified during the measurement period
